Assessment of the Effects and Impacts Caused by

# Hurricane Joaquin

## The Bahamas

**Economic Commission for Latin America and the Caribbean (ECLAC)**

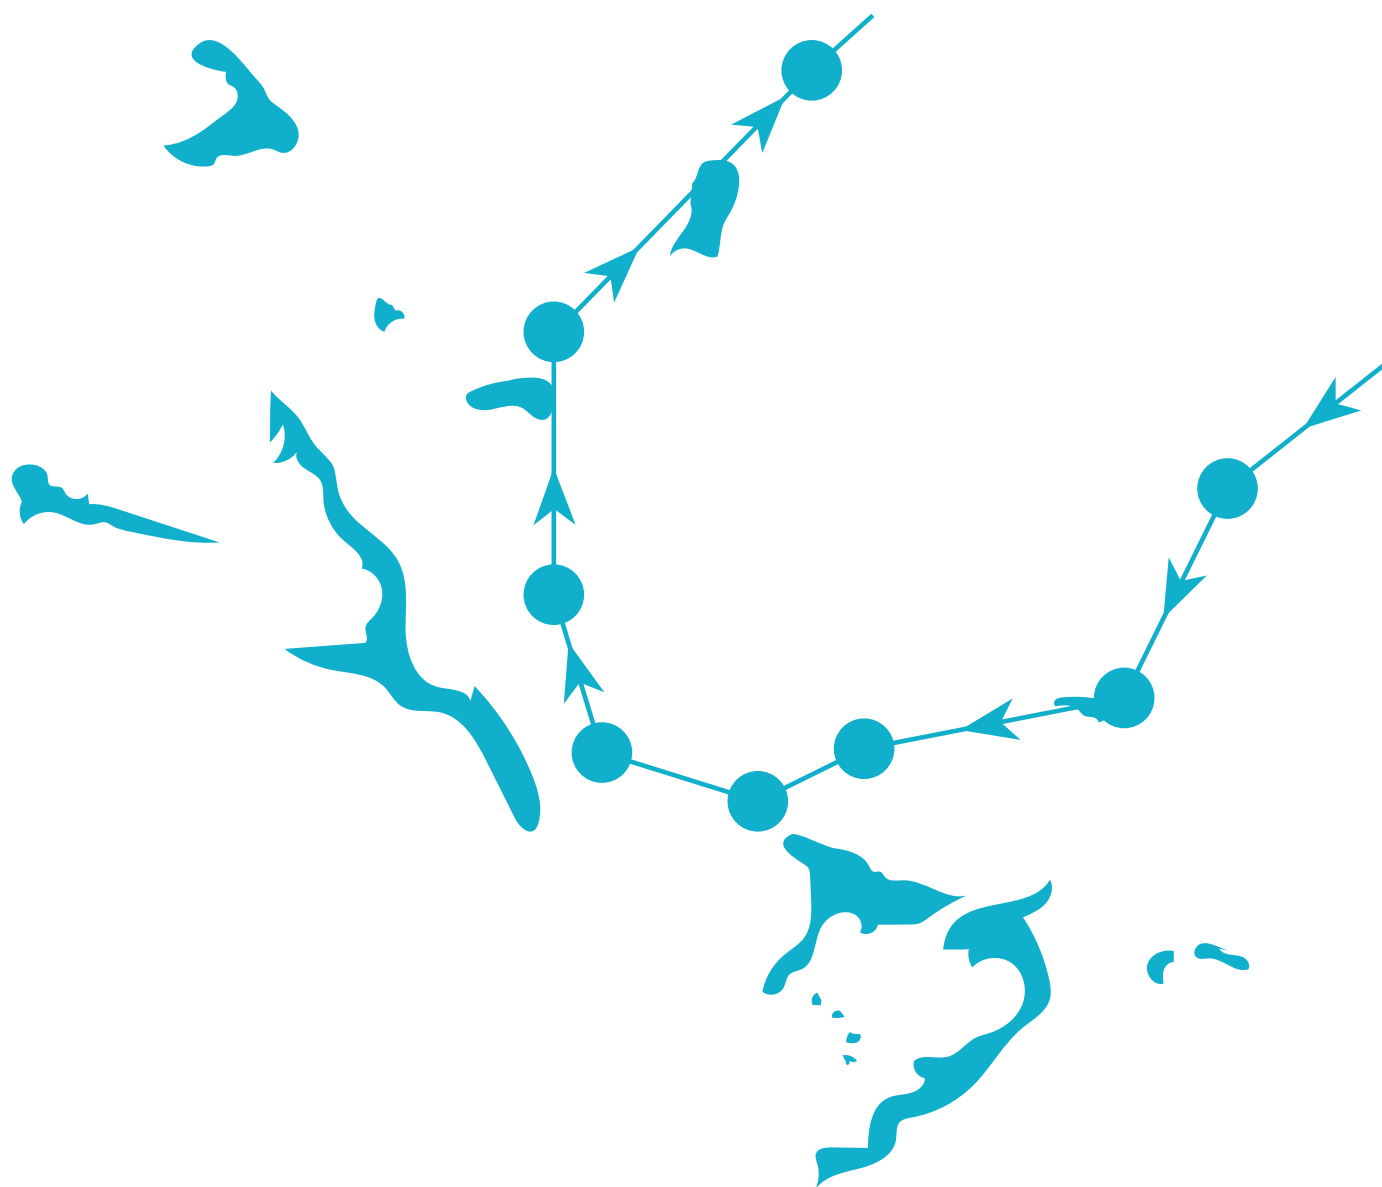
**Map 2-** Trajectory of hurricane Joaquin  
1 October, 11: a.m. AST

Considering the dispersion of the settlements in the affected islands, and the interruption of power and telecommunications caused by hurricane Joaquin, it is necessary to draw attention to early warning systems and protocols. Even though multiple advisories were issued on 30 September, most people had already left their places of work and the alerts were not successfully transmitted to the entire population. In addition, the hurricane affected most islands since Wednesday evening and Thursday early morning, but Acklins and Crooked Island only received a hurricane warning on 1 October (Map 2). At 6:35 a.m. AST the government of The Bahamas issued a hurricane warning to include Acklins, Crooked Island, and Mayaguana of the southeastern Bahamas, and the tropical storm warning remained for the rest of the southeastern Bahamas (Long Cay, the Inaguas, and the Ragged Islands) and Andros Island, and a hurricane watch to include Bimini. Joaquin continued to move southwest at 5 mph (7km/h), and the eye was estimated to pass over Samana Cays around 12:00 p.m. AST.

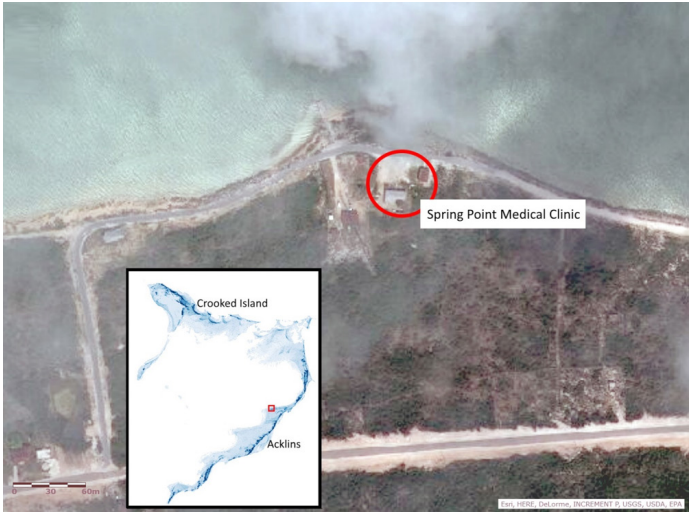
Figure 1- Spring Point Medical Clinic

The health centre is located close to the ocean (Figure 1) and as a result suffered from major flooding. The roof incurred damage because of high wind resulting in loss of shingles, causing leakages through the roof. The generator was destroyed because of water damage; and all vaccines and insulin were lost. The storage facility sustained major flooding, causing destruction of all medical supplies that were stored before the hurricane. The well water was contaminated with saltwater intrusion; however, there was no faecal contamination. Furthermore, the doctor’s government residence sustained damage due to flooding.

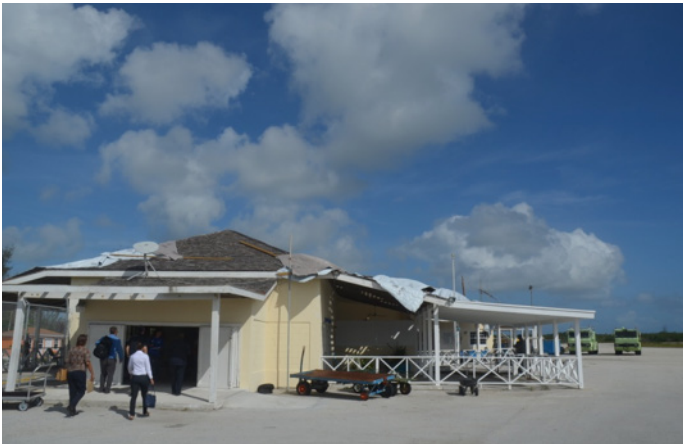
**Photo 1-** San Salvador Airport

The terminal buildings located in Acklins, Crooked Island, Long Island (Deadman’s Cay) and San Salvador are all similar, airports consist of a runway and neither have guidance or communication systems. The terminals are single-story structures of reinforced concrete and masonry. The hurricane produced damage in all terminal buildings, but they are partially recovered and all presently functioning. In Rum Cay there was no building terminal.

Runways of all five airports inspected are clear of debris and functioning, but require repairs. They show insufficient previous maintenance unrelated to hurricane Joaquin. The costs of these repairs have not been estimated due to lack of information regarding their design parameters and their estimation could be part of a comprehensive infrastructure development master plan. The total damage to airports in Acklins, Crooked Island, Long Island and San Salvador is estimated at \$1,771,964.

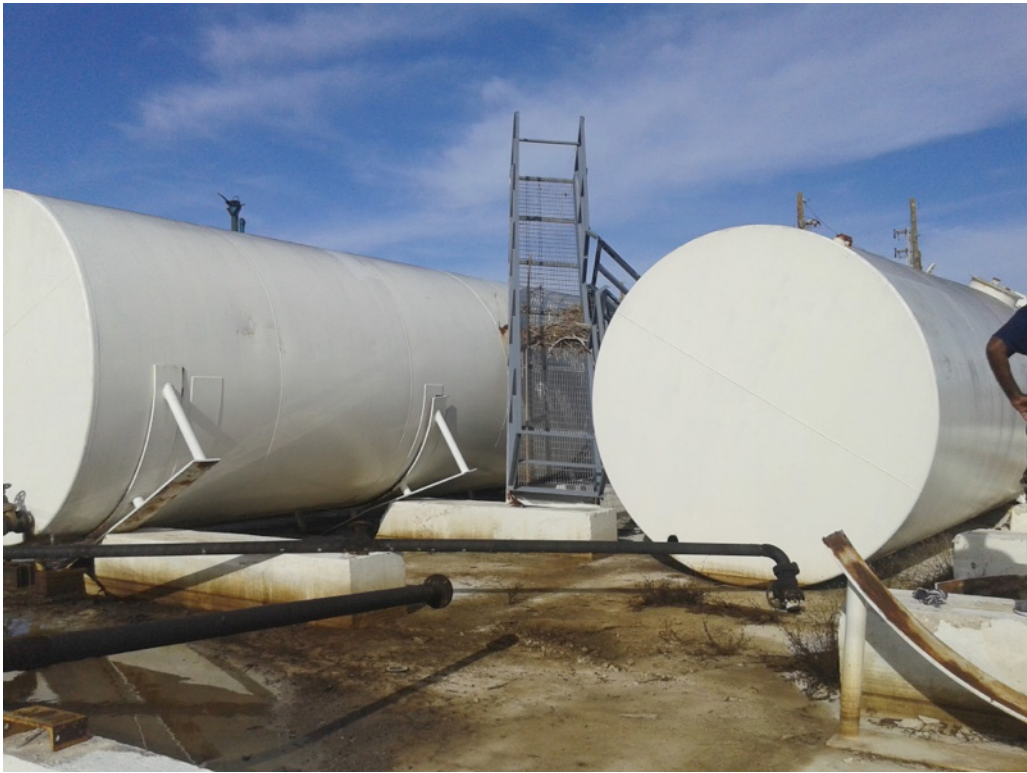
Photo 3- Damage to fuel tanks

Another effect of the storm surge on the Landrail Point Power Station was the dislocation of two 25,000 gallon tanks used for the storage of diesel. The tanks were ripped from their concrete bases, and an estimated 7,000 to 10,000 gallons of diesel leaked out through a pipe that had become disconnected. Soil sampled from a drainage area nearby the tank was found to be contaminated with diesel, as evidenced by the presence of strong fumes which were noted by the disaster assessment team. This spill warrants further investigation, to determine the extent of soil contamination, possible options for remediation, and potential danger to the water table. The tanks themselves are salvageable, but will require a crane to be put back into place.
